Case Study:

The Gulbenkien Café at Kent University

Project: The Gulbenkien Café

Location: Kent University,
Canterbury

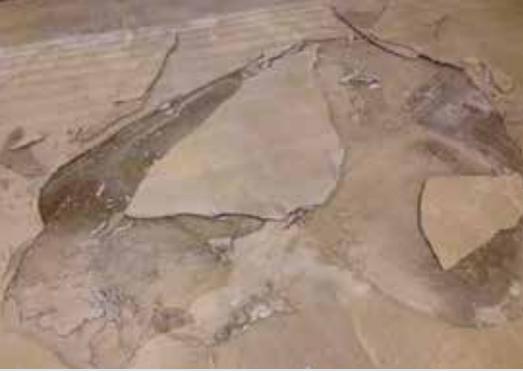
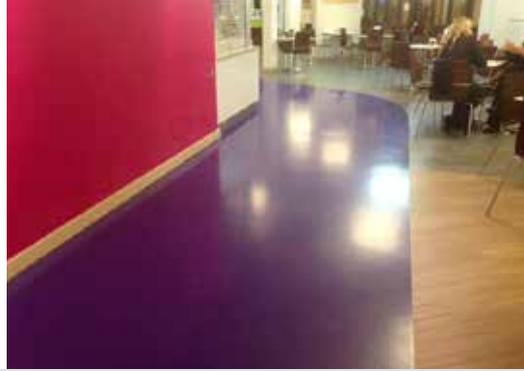
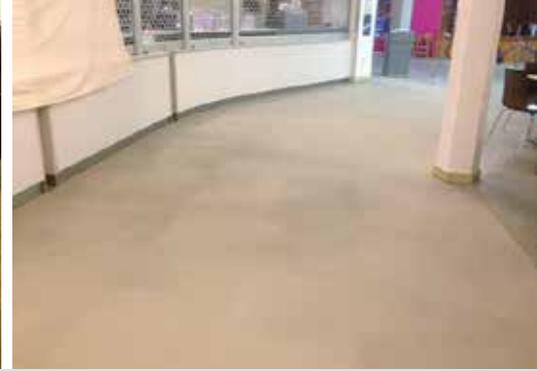
SW Flooring removed the existing floorcoverings, and it became apparent that there was a moisture problem with the subfloor. SW Flooring were also presented with a variety of subfloors, ranging from 50 mm paving slabs laid onto 75 mm of sand, adjoining timber sections, ceramic tiles and screed. All with their own extremities and movement tolerances. Previous installations had been undertaken by other contractors by applying DPMs and latex smoothing compounds on top

of each other at each stage of failure, which resulted in the moisture present in the subfloor, just constantly working its way to the surface failing each layer of preparation as it went.

SW Flooring started by removing all the existing latex smoothing compounds by hand with a small mechanical Kango drill. The timber section was replaced incorporating a structural DPM, and then was overlaid with a 6 mm of plyboard to increase rigidity. SW Flooring had to ensure the cafe was open at 8:00 am each morning during the project. This was achieved by making up the level differences with sand each night and then covering with Cordex to eliminate any trip hazard.

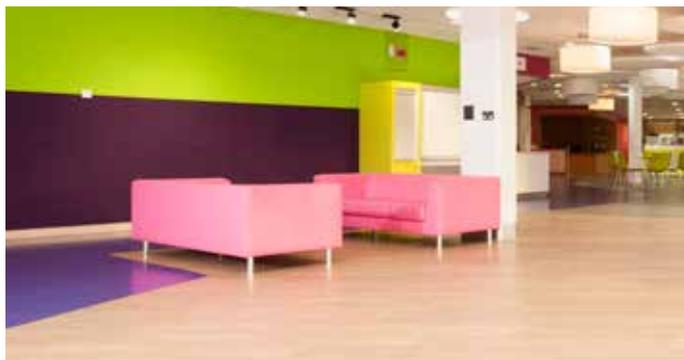
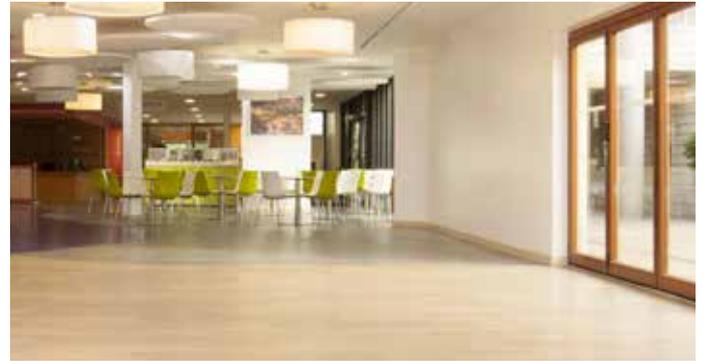
The specification was to apply 2 coats of Uzin PE 480 to the paving slabs, incorporating an accelerator to speed up the drying time, for the reopening of the cafe in the morning. The second coat was fully blinded to create a mechanical key for the smoothing compound, and UZIN NC 182 was used in isolated sections to repair where the different substrates joined. The timber and plywood areas were primed using UZIN PE 630 and UZIN NC 175 fibre-reinforced smoothing compound was applied between 6 mm to 10 mm. This created a subfloor, that was suitable to receive any floorcovering of the Universities choice.
